Re: 2018 Sanitary Survey Report

PWS ID#: WY5601439 C

Enclosed is a report prepared for the U. S. Environmental Protection Agency (EPA) following a sanitary survey of the Bar-B-Bar Meadows water system on September 20, 2018.

2018 EPA Region 8 WY SANITARY SURVEY FORM INVENTORY

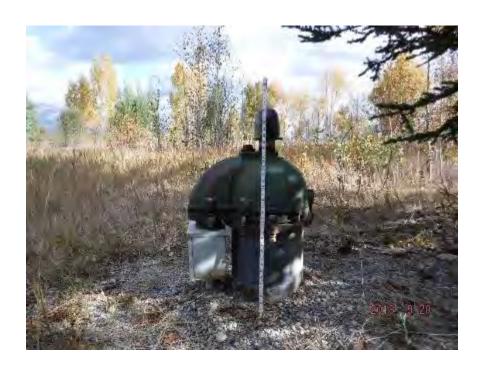
Photo #: 1

Subject: Well #1 (WL01)

Comments: North view. The well casing is 16 inches above grade and the vent is 29 inches above grade.

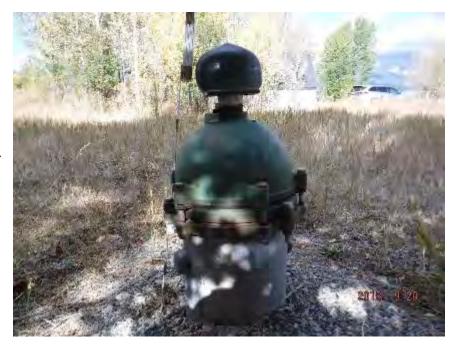
Photo #: 2

Subject: Well #1 (WL01)

Comments: West view. The Booster Pump (PF01) and 10K Gal Storage Tank (ST01) building is visible in the background at approximately 80 feet

distant.

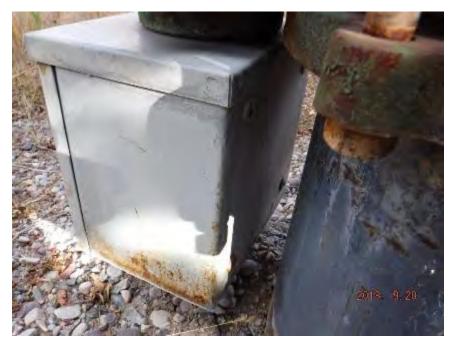
Photo #: 3

Any holes or openings observed in the well or its appurtenances? @	⊠ Yes □ No □ NA	⊠ Yes □ No □ NA	☐ Yes ☐ No ☐ NA
If yes, describe.	Open electrical junction box mounting holes. Holes sealed by Operator post survey.	Open electrical junction box mounting holes. Holes sealed by Operator post survey.	
Does the well have a sanitary seal with tightly bolted cap? @ (May need operator to open well cap to verify; explain why if unable to verify)	☐ Yes No ☐ Unknown ——	☐ Yes No ☐ Unknown ——	☐ Yes ☐ No☐ Unknown
Is a gasket visible?	⊠ Yes □ No □ NA	⊠ Yes □ No □ NA	☐ Yes ☐ No ☐ NA
Does the well cap move?	⊠ Yes □ No □ NA	⊠ Yes □ No □ NA	☐ Yes ☐ No ☐ NA
Explain	Loose bolts. Bolts tightened by Operator post survey.	Loose bolts. Bolts tightened by Operator post survey.	
Is well vented (vent not required)?	⊠ Yes □ No □ NA	⊠ Yes □ No □ NA	☐ Yes ☐ No ☐ NA
What is the height from the ground level to the screen of the vent (inches)?	<u>29</u>	<u>24.5</u>

Subject: Well #1 (WL01)

Comments: Open electrical junction

box mounting holes.

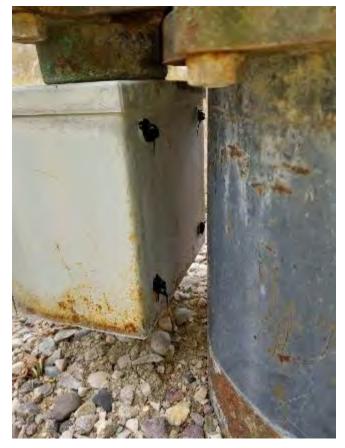
Photo #: 4

Subject: Well #1 (WL01)

Comments: Photo provided by operator.

The electrical junction box mounting

holes have been sealed.

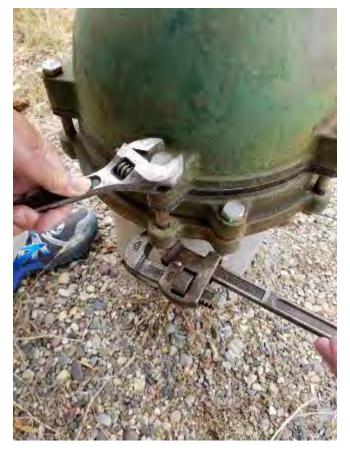
Photo #: 5

Subject: Well #1 (WL01)

Comments: Photo provided by operator showing the tightening of the loose well cap

bolts.

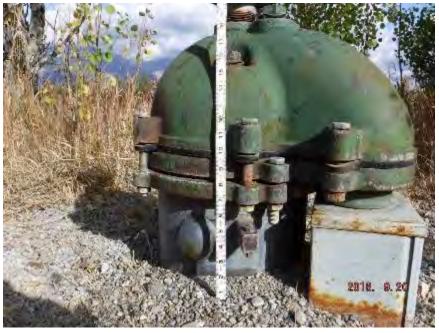
Photo #: 6

Subject: Well #2 (WL02)

Comments: The well casing is 10 inches above grade. Northwest view.

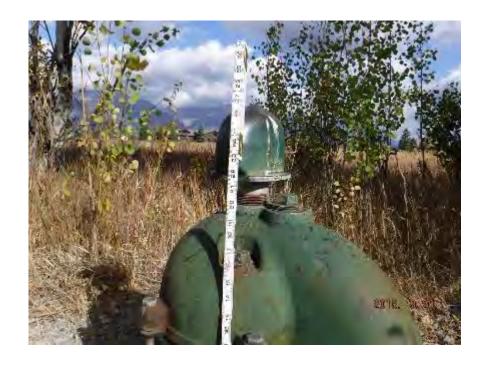
Photo #: 7

Subject: Well #2 (WL02)

Comments: North view. The vent

is 24.5 inches above grade.

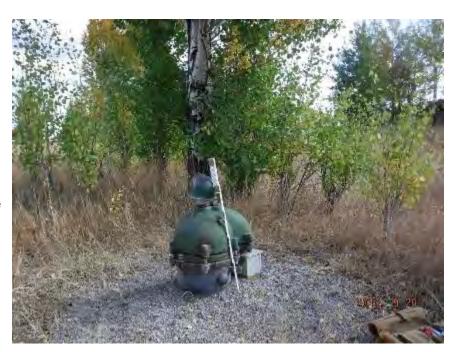
Photo #: 8

Subject: Well #2 (WL02)

Comments: Northeast view. The Booster Pump (PF01) and 10K Gal Storage Tank (ST01) building is visible in the background on the right at approximately 110 feet distant.

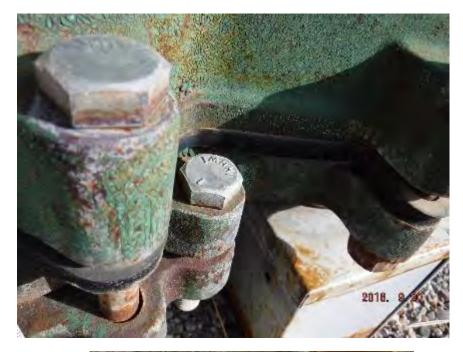
Photo #: 9

Subject: Well #2 (WL02)

Comments: Open electrical junction

box mounting holes.

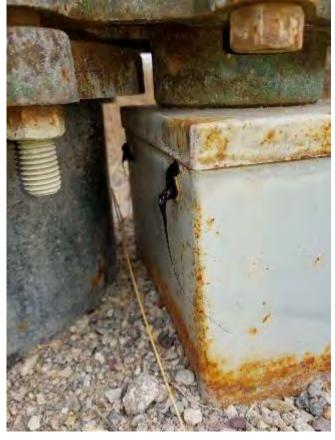
Photo #: 10

Subject: Well #2 (WL02)

Comments: Photo provided by operator.

The electrical junction box mounting

holes have been sealed.

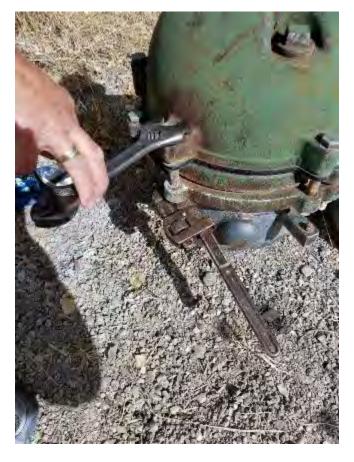
Photo #: 11

Subject: Well #2 (WL02)

Comments: Photo provided by operator showing the tightening of the loose well cap

bolts.

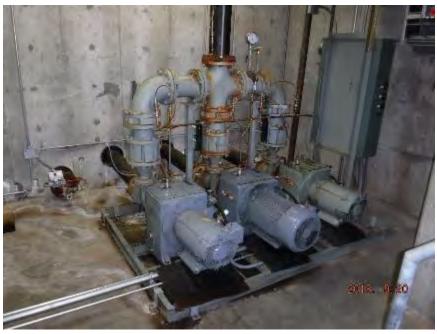
Photo #: 12

Subject: Booster Pump (PF01)

Comments: The three centrifugal booster pumps are fed from the 10K Storage Tank (ST01) which is located at the back wall of the building.

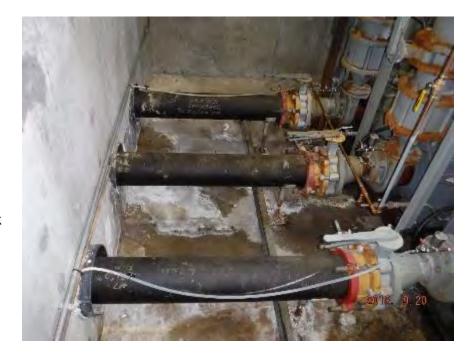
Photo #: 13

Subject: Booster Pump (PF01)

Comments: The 10K Storage Tank

wall is visible on the left.

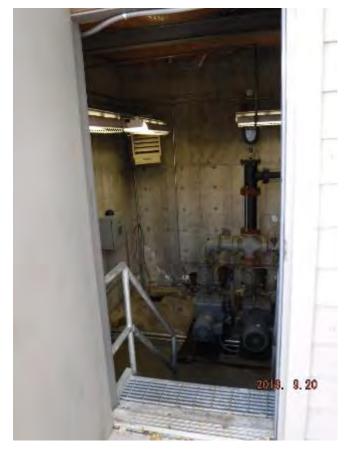
Photo #: 14

Subject: Booster Pump (PF01)

Comments: Building access.

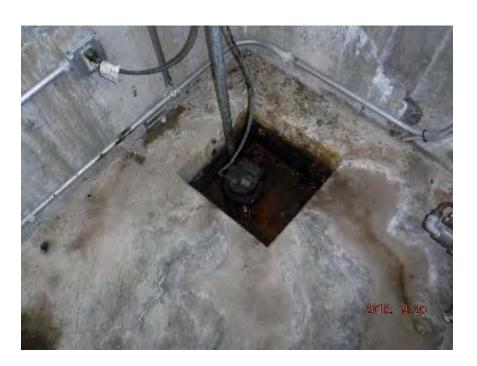
Photo #: 15

Subject: Booster Pump (PF01)

Comments: Building sump pump.

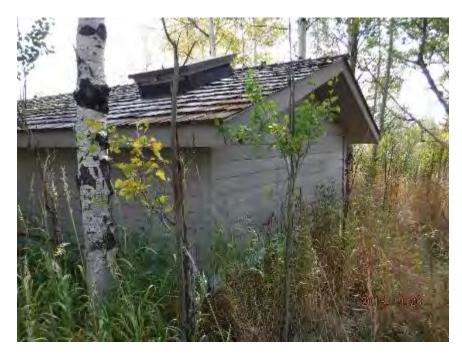
Photo #: 16

Subject: 10K Storage Tank

(ST01)

Comments: Storage tank located inside building at this end. Tank hatch

is visible on the roof.

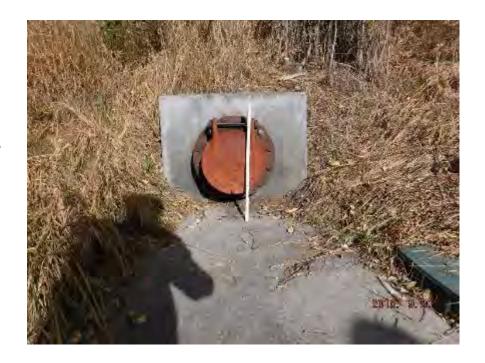
Photo #: 17

Is the discharge visible?	☐ Yes ☐ No ☐ NA	☐ Yes ☐ No ☐ NA	☐ Yes ☐ No ☐ NA
Does the overflow have an air gap of 3 or more pipe diameters above the entrance to any storm or sanitary sewer? @	☐ Yes ☐ No ☒ NA	☐ Yes ☐ No ☐ NA	☐ Yes ☐ No ☐ NA
Comments about overflow:	Overflow outfall variance reported.

Subject: 10K Storage Tank

(ST01) Overflow

Comments: The overflow outfall is 6 inches above grade (reported variance) with a flapper valve.

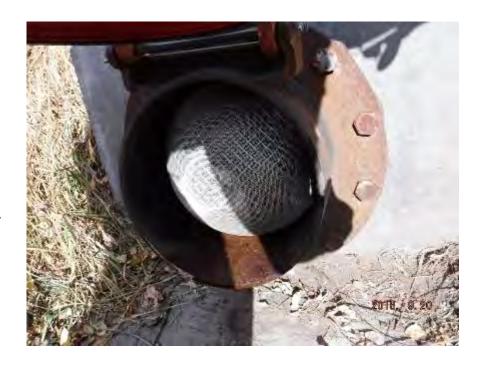
Photo #: 18

Subject: 10K Storage Tank

(ST01) Overflow

Comments: #24-mesh corrosion-resistant screen behind flapper valve.

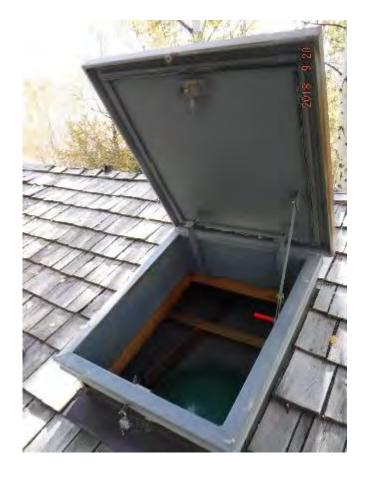
Photo #: 19

Subject: 10K Storage Tank

(ST01) Access Hatch

Comments: Tank roof and interior

hatch lid (green) are visible inside the open

exterior access hatch.

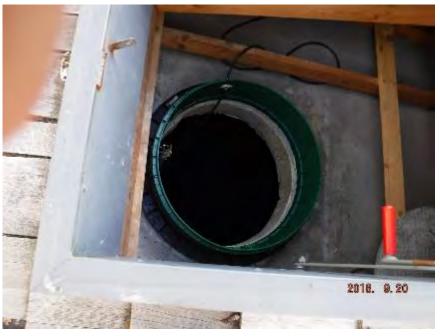
Photo #: 20

Subject: 10K Storage Tank

(ST01) Access Hatch

Comments: Open interior hatch.

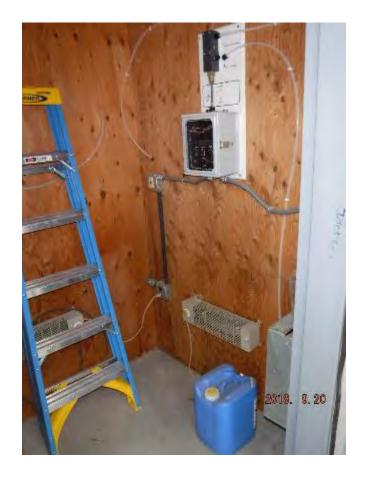
Photo #: 21

Subject: Former Treatment

Comments: Located inside Booster

Pump (PF01) building.

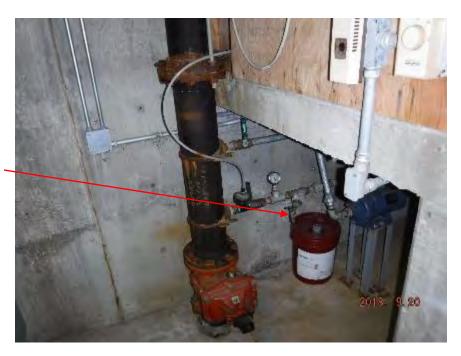
Photo #: 22

Subject: Former Treatment

Comments: Located inside Booster Pump (PF01) building. A common tap is visible here on the chlorination injection loop, located between the booster pumps and distribution.

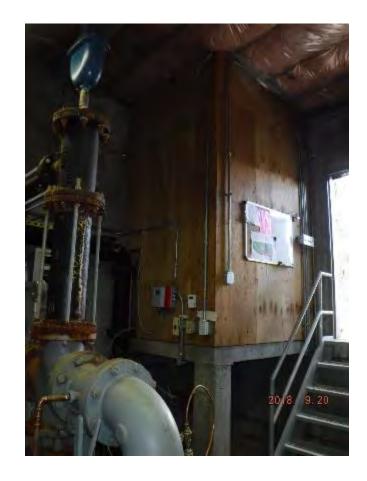
Photo #: 23

Subject: Former Treatment

Comments: Located inside Booster

Pump (PF01) building.

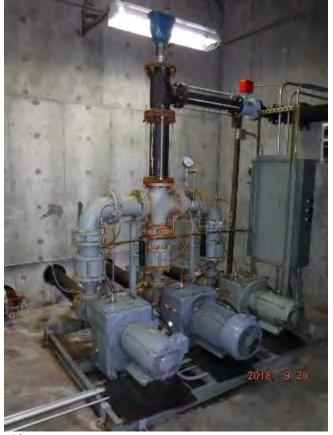
Photo #: 24

Subject: Booster Pump (PF01)

Comments: An air release valve is

visible at the top of the photo.

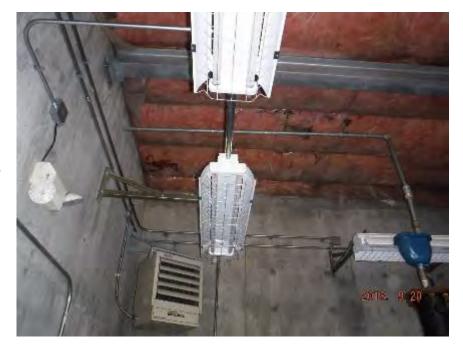
Photo #: 25

Subject: Booster Pump (PF01)

Comments: Air release valve

plumbed to the exterior of the building.

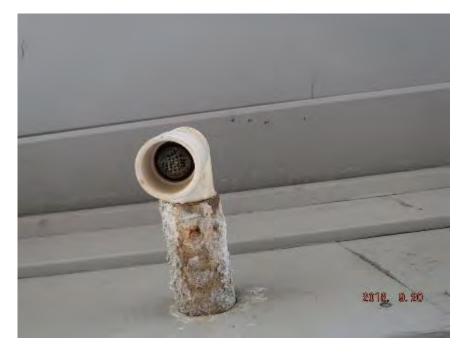
Photo #: 26

Subject: Booster Pump (PF01)

Comments: Properly screened air release valve piping discharge located on the exterior of the building.
